# VEHICLE INSPECTION REPORT

**GY67JVO**

## Toyota C-Hr 1.2T Dynamic 5dr

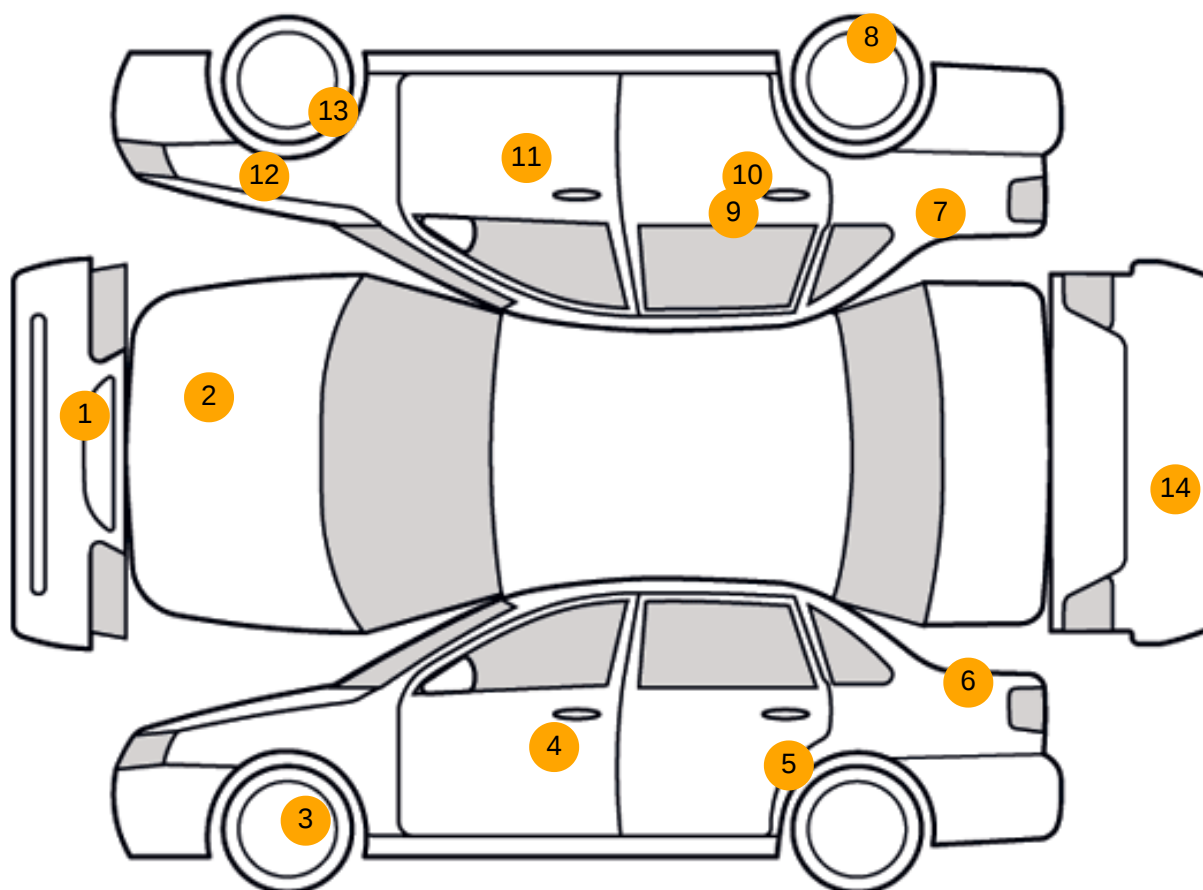
## Condition Check

1: Bumper Front  
Poor Previous Repair  
Poor Paint

4: Door nsf  
Poor Previous Repair  
Rippled Up To 30%
