## VEHICLE INSPECTION REPORT

**HG63LSC**

### Honda Civic 1.8 i-VTEC ES 5dr

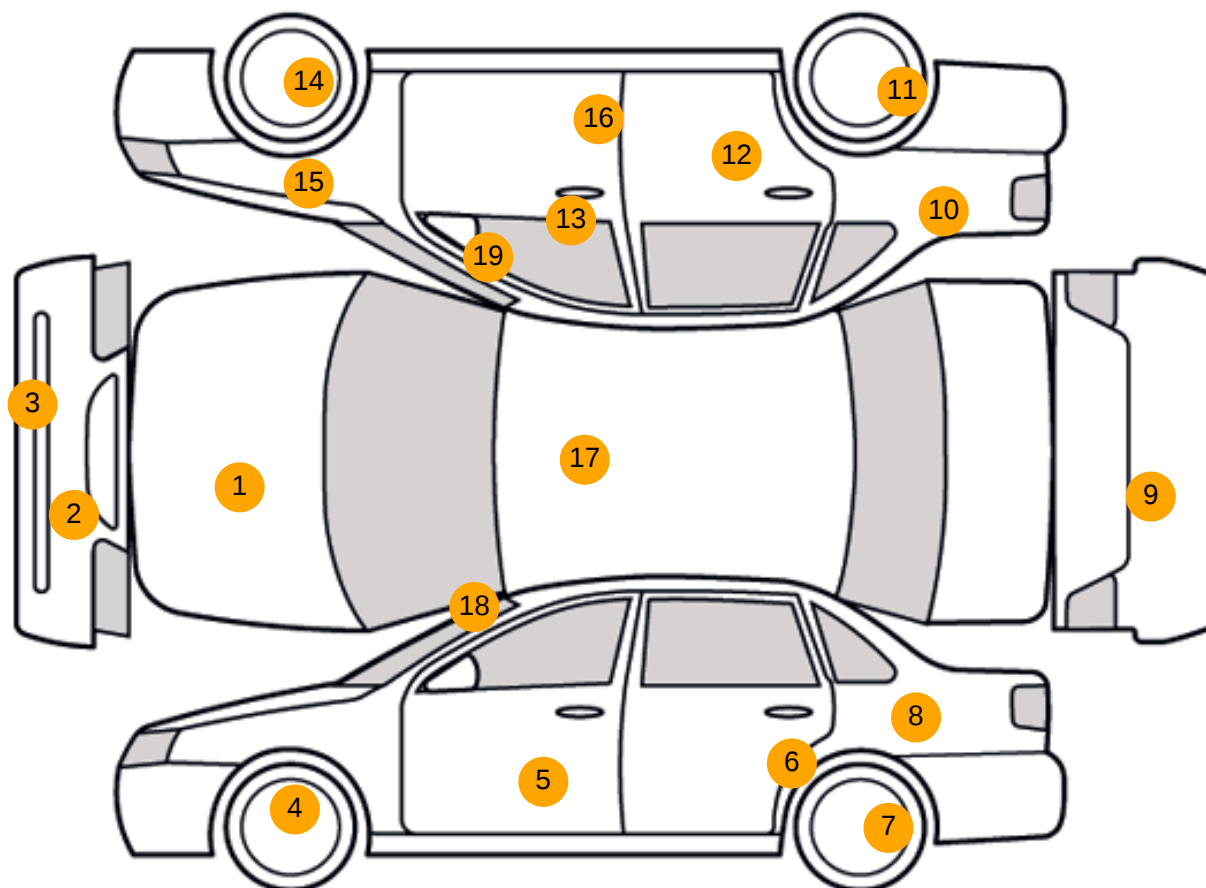
## Condition Check

2: Bumper Front  
Dented  
With Paint Damage

3: Bumper Front Moulding  
Broken  
Replace

5: Door nsf  
Dented  
With Paint Damage

6: Door nsr  
Poor Previous Repair  
Paint Flake

12: Door osr  
Poor Previous Repair  
Rippled UpTo 30%

13: Door osf  
Dented  
With Paint Damage

17: Roof  
Rusted  
Over 5mm

20: Switches And Controls  
Broken  
Replace
