## VEHICLE INSPECTION REPORT

**EJ61UUM**

### Audi A5 2.0 TDI 143 S Line 5dr Multitronic

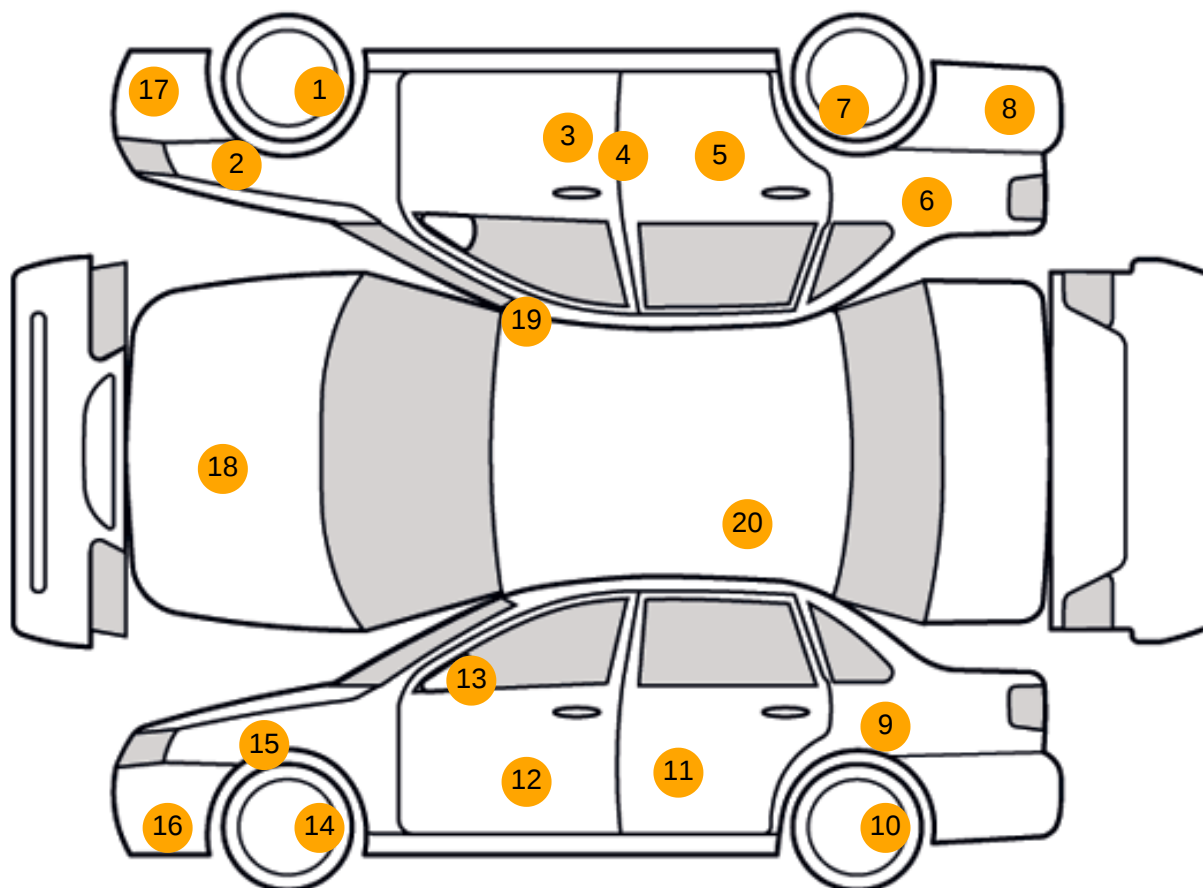
## Condition Check

2: Wing osf  
Dented  
With Paint Damage

6: Qtr Panel osr  
Poor Previous Repair  
Poor Paint

8: Bumper Rear  
Poor Previous Repair  
Paint Flake

9: Qtr Panel nsr  
Dented  
With Paint Damage

12: Door nsf  
Dented  
With Paint Damage

15: Wing nsf  
Dented  
With Paint Damage

21: Door Pad osf  
Broken  
Replace

23: Tyre osf  
Damaged  
Replace
