# VEHICLE INSPECTION REPORT

**GX17ODV**

## Vauxhall Viva 1.0 SE 5dr

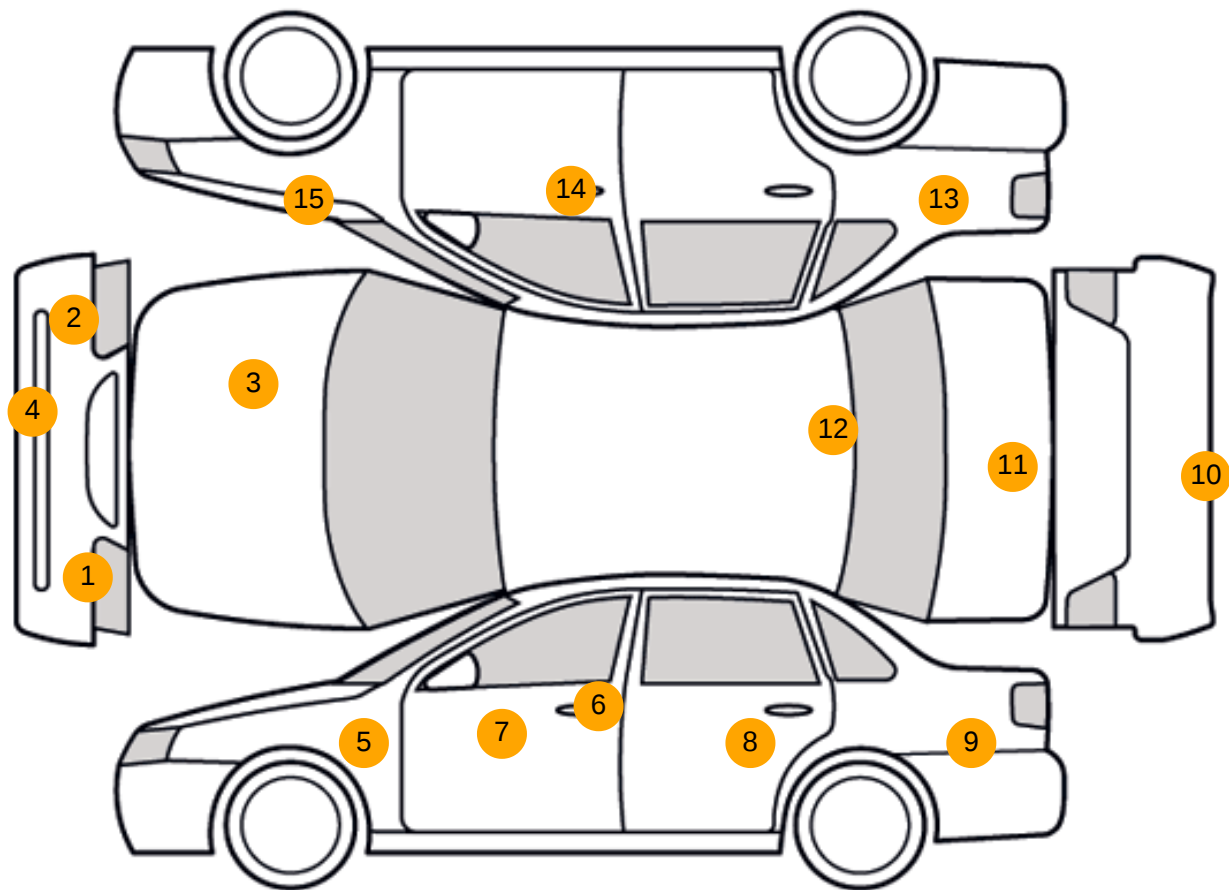
## Condition Check

4: Bumper Front Moulding  
Broken  
Replace

5: Wing nsf  
Poor Previous Repair  
Poor Paint

12: Aerial  
Broken  
Replace
