# VEHICLE INSPECTION REPORT

**GX65ZZY**

## Vauxhall Viva 1.0 ecoFLEX SE 5dr

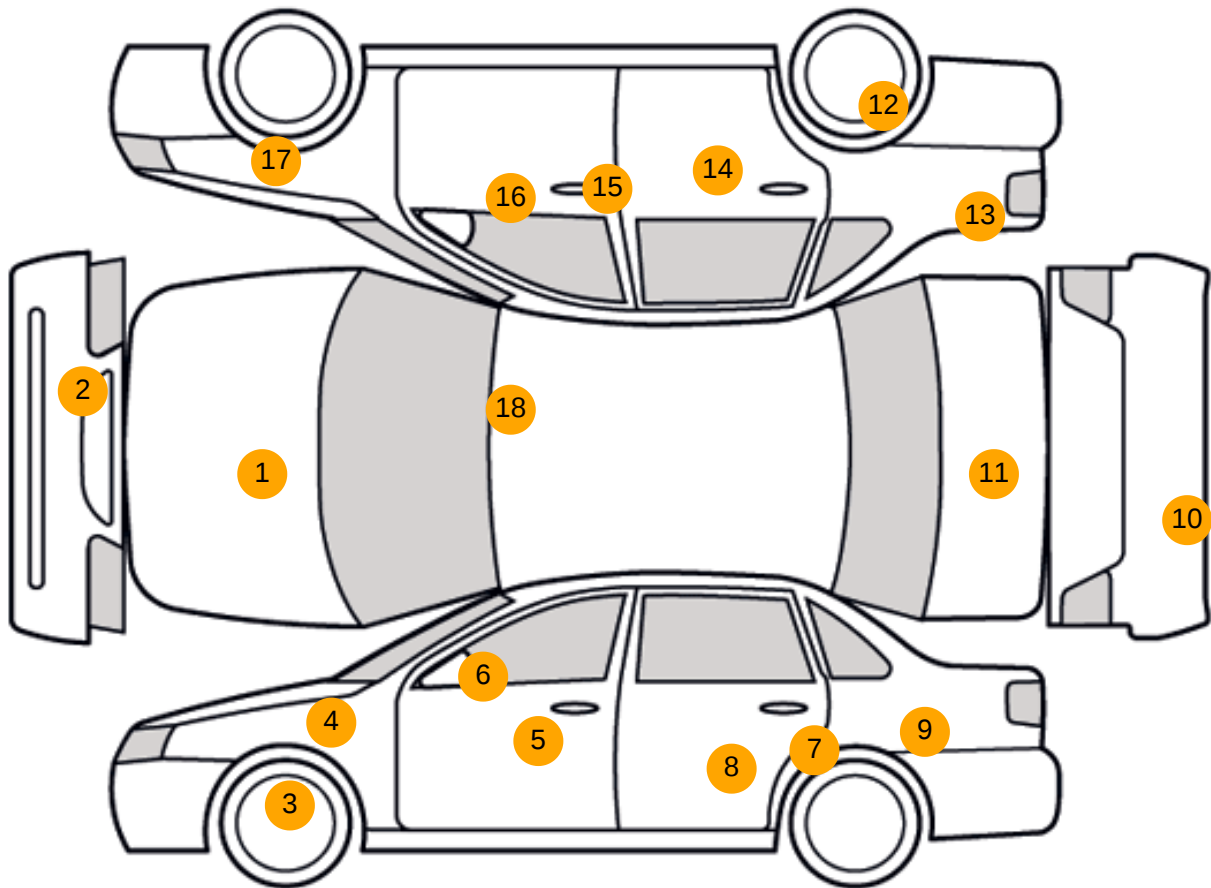
## Condition Check

2: Bumper Front  
Dented  
With Paint Damage

3: Wheel Trim nsf  
Broken  
Replace

5: Door nsf  
Poor Previous Repair  
Rippled UpTo 30%

8: Door nsr  
Poor Previous Repair  
Rippled UpTo 30%

12: Wheel Trim osr  
Missing  
Replace

14: Door osr  
Poor Previous Repair  
Rippled UpTo 30%

16: Door osf  
Dented  
With Paint Damage
