# VEHICLE INSPECTION REPORT

**GU62KCA**

## BMW 1 Series 118d Sport 5dr Step Auto

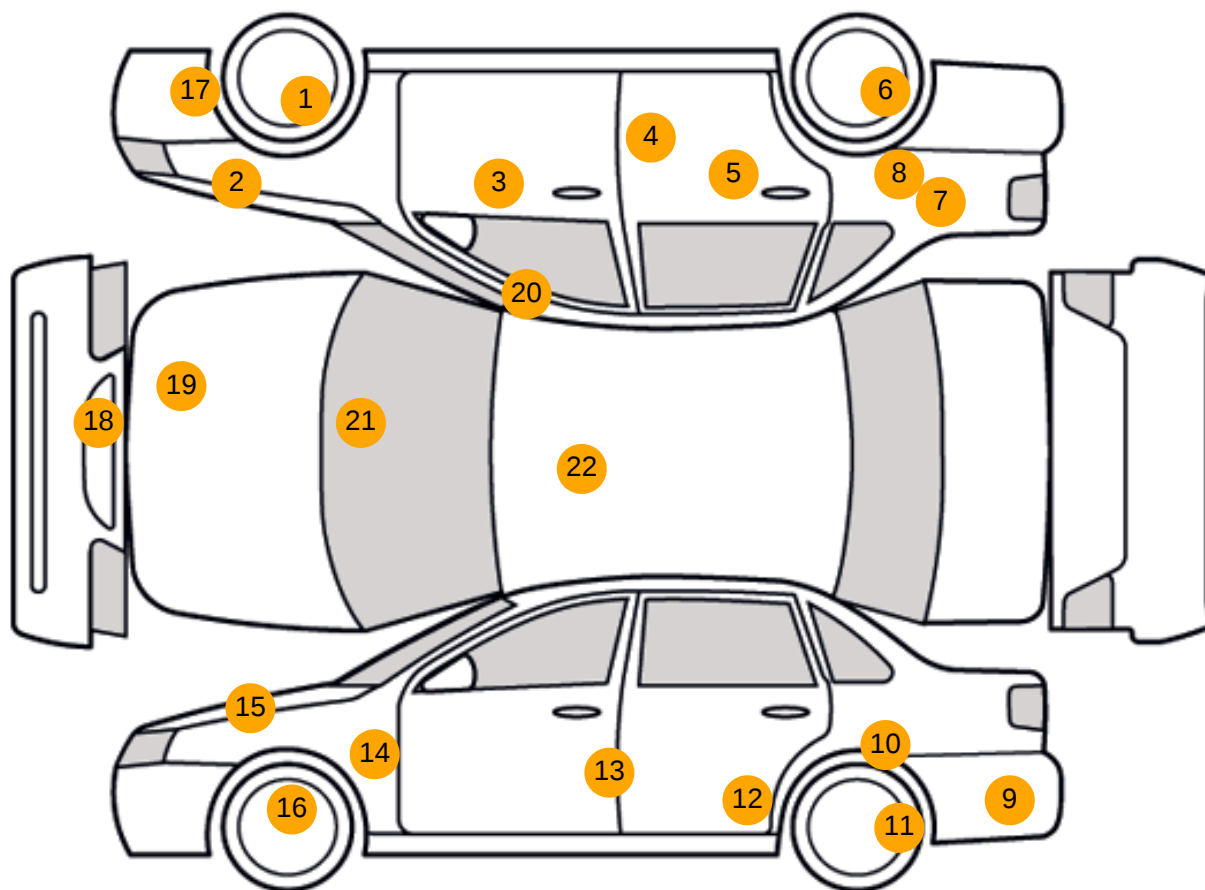
## Condition Check

1: Wheel osf  
Corroded  
Light

6: Wheel osr  
Corroded  
Light

10: Qtr Panel nsr  
Dented  
With Paint Damage

11: Wheel nsr  
Corroded  
Light

12: Door nsr  
Dented  
With Paint Damage

16: Wheel nsf  
Corroded  
Light
