VEHICLE INSPECTION REPORT

LB15FGP

Kia Rio 1.25 SR7 5dr

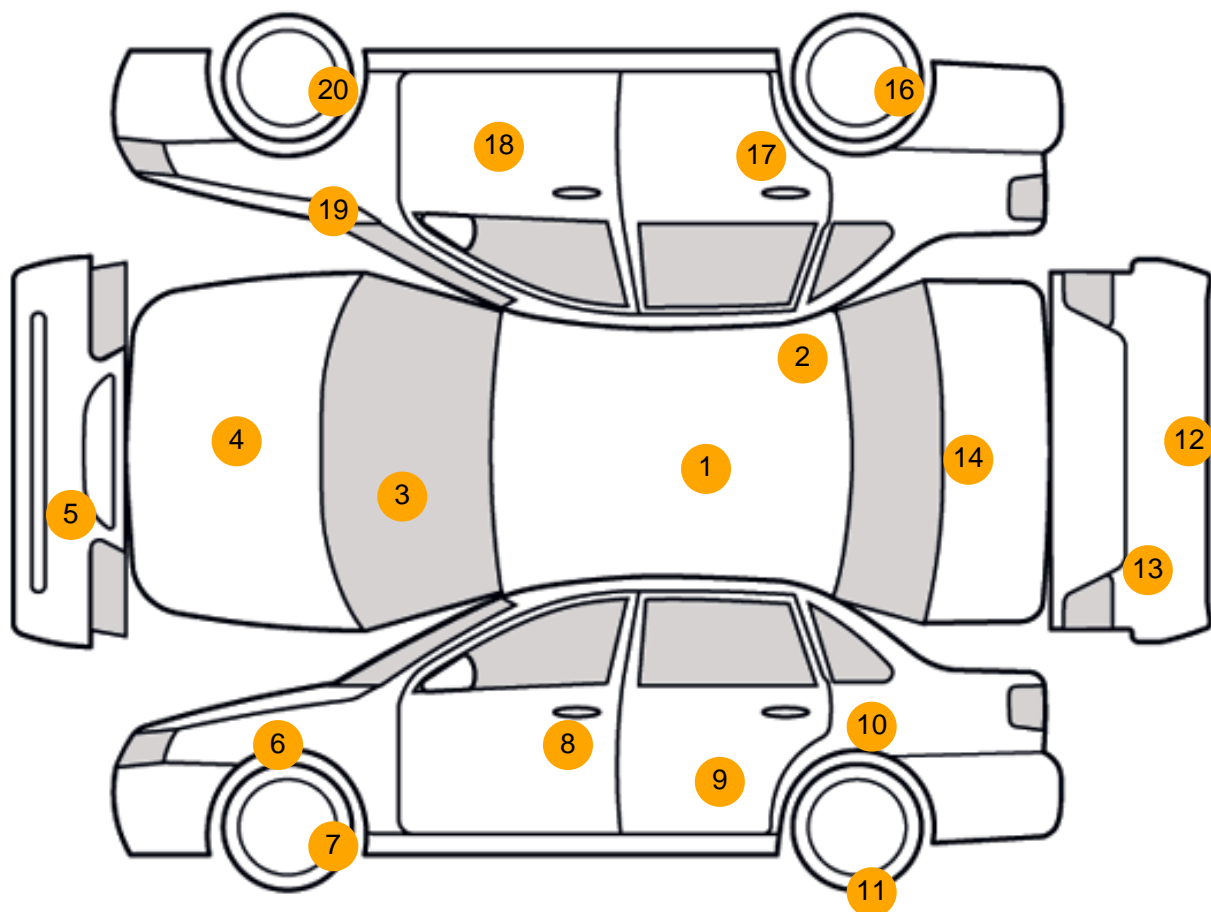
Condition Check

5: Bumper Front
Cracked
UpTo 25mm

6: Wing nsf
Dented
With Paint Damage

8: Door nsf
Dented
With Paint Damage

9: Door nsr
Dented
With Paint Damage

10: Qtr Panel nsr
Dented
With Paint Damage

12: Bumper Rear
Cracked
Over 25mm

13: Reflector nsr
Broken
Replace

17: Door osr
Rusted
Over 5mm
