VEHICLE INSPECTION REPORT

LR57NYS

Nissan Note 1.6 SVE 5dr

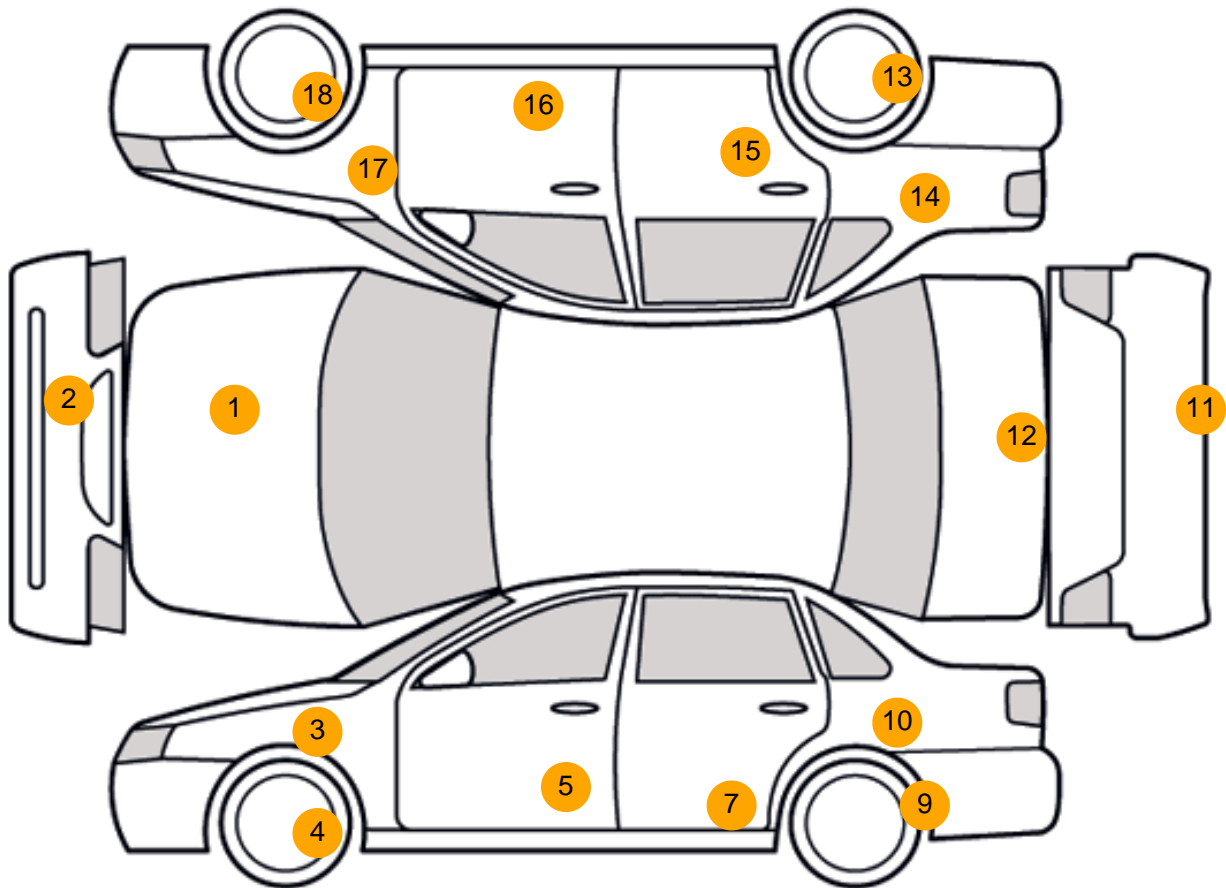
Condition Check

2: Bumper Front
Poor Previous Repair
Poor Paint

11: Bumper Rear
Poor Previous Repair
Rippled UpTo 30%

14: Qtr Panel osr
Dented
With Paint Damage
