VEHICLE INSPECTION REPORT

GU61RYO

Toyota Verso-S 1.33 Dual VVT-i TR 5dr

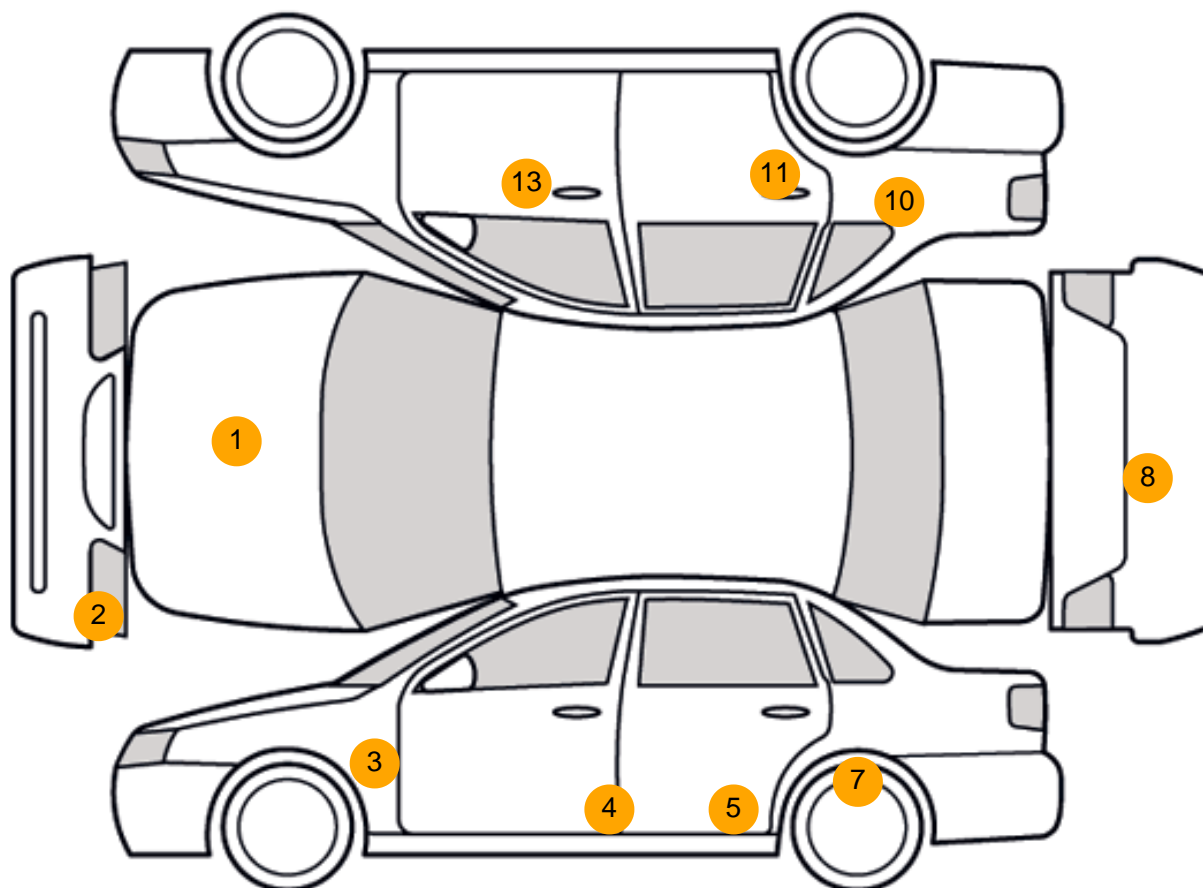
Condition Check

4: Door nsf
Dented
With Paint Damage

10: Qtr Panel osr
Poor Previous Repair
Poor Paint

17: Tyre nsf
Worn
Replace
