VEHICLE INSPECTION REPORT

AF60YFM

nama
GRADE
4

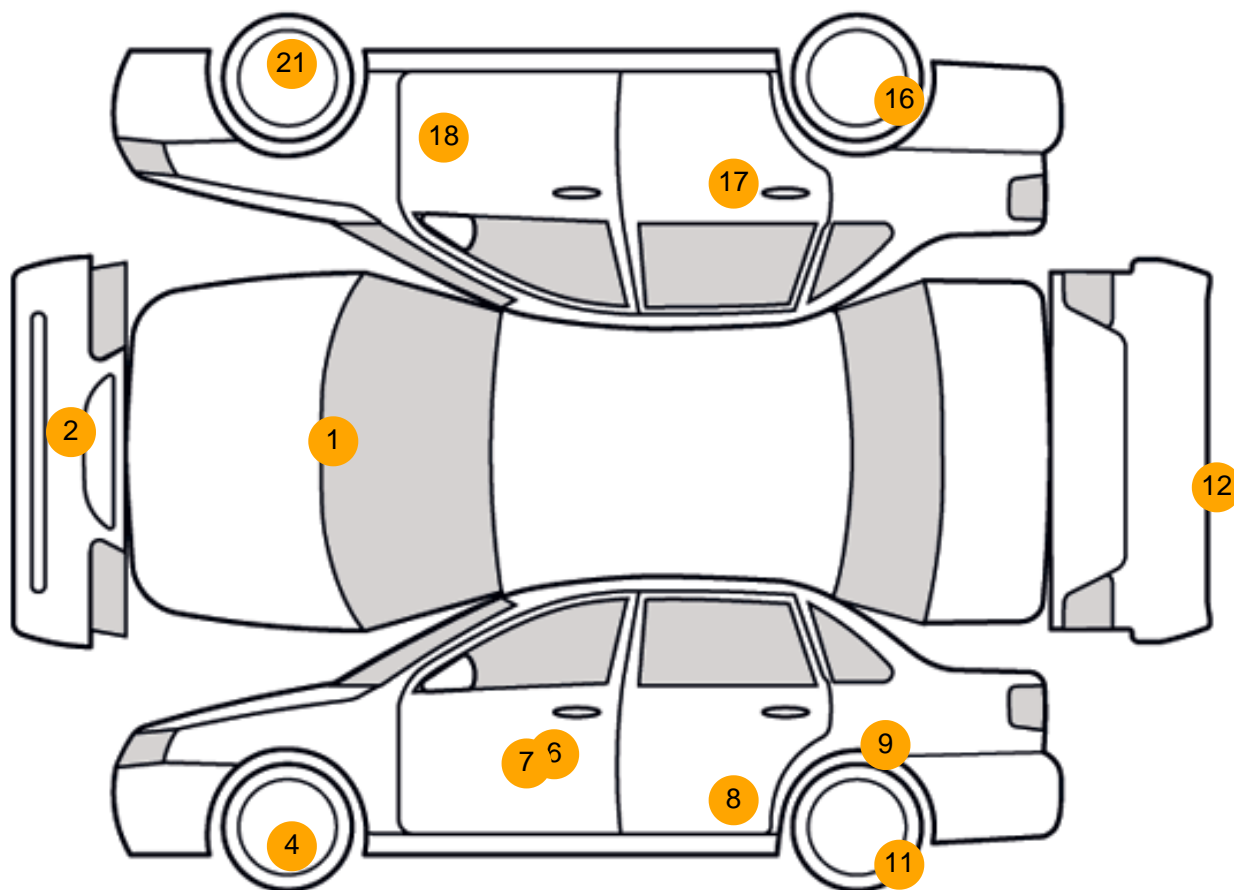
Condition Check

1: Bonnet
Poor Previous Repair
Poor Paint

8: Door nsr
Dented
With Paint Damage

17: Door osr
Dented
With Paint Damage

23: Tyre nsf
Worn
Replace
