VEHICLE INSPECTION REPORT

OV60WYJ

Honda CR-V 2.0 i-VTEC ES 5dr

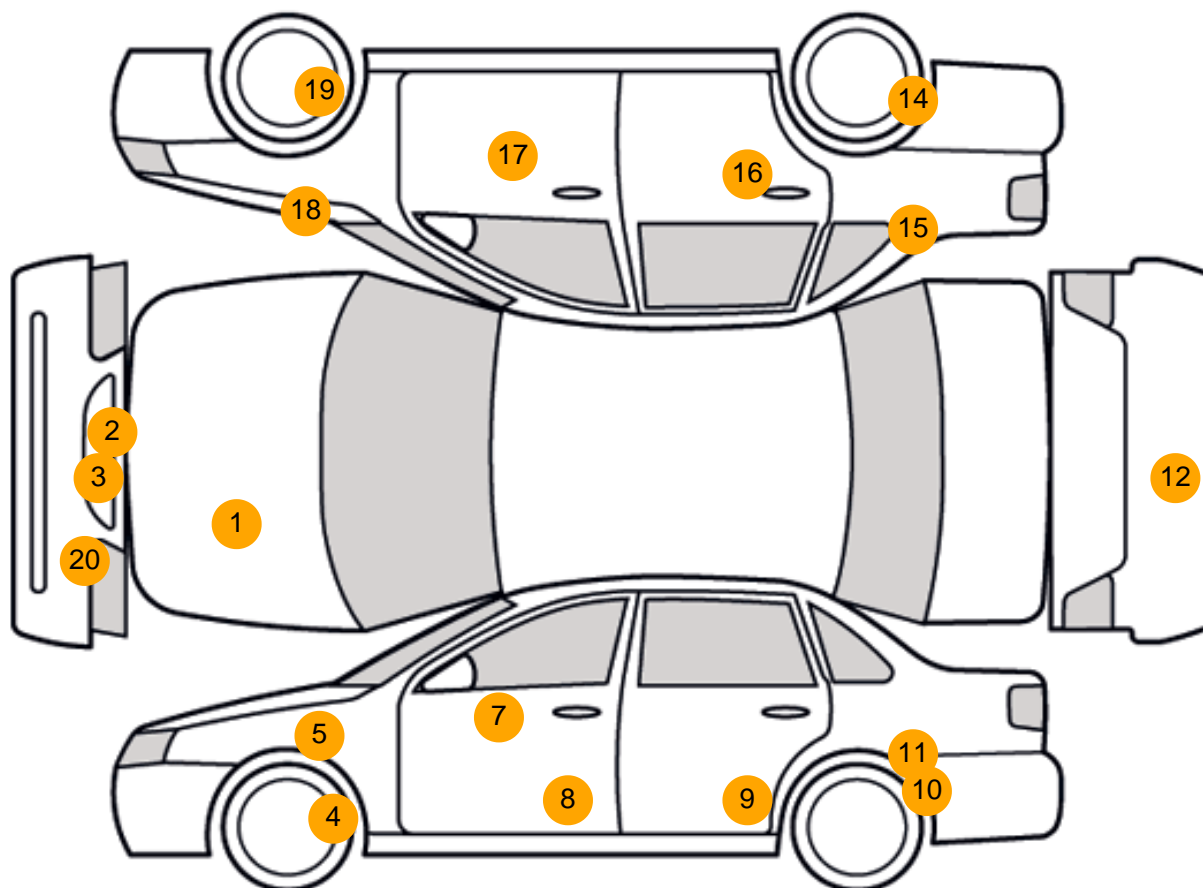
Condition Check

£65 ADDITIONAL FEE. Last service 01/08/2024 at 167741 miles. (10 services (5 main dealer). Front bumper misaligned
