VEHICLE INSPECTION REPORT

HN12XGZ

Nissan Micra 1.2 Kuro 5dr

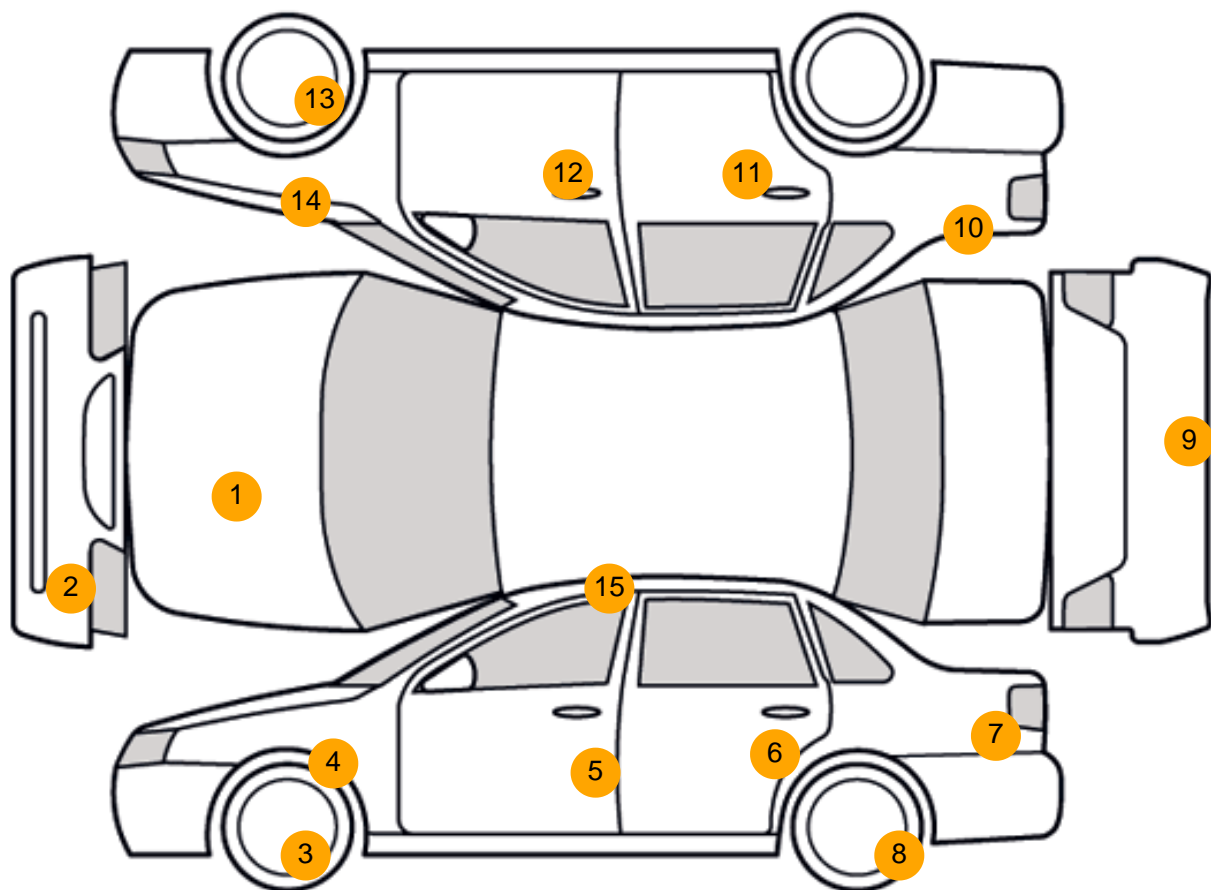
Condition Check

4: Wing nsf
Dented
With Paint Damage

5: Door nsf
Dented
With Paint Damage

6: Door nsr
Dented
With Paint Damage

7: Qtr Panel nsr
Dented
With Paint Damage

11: Door osr
Dented
With Paint Damage
