VEHICLE INSPECTION REPORT

RK56XHW

Nissan X-Trail 2.5 16v Aventura 5dr Auto

Cat: C
Inspection

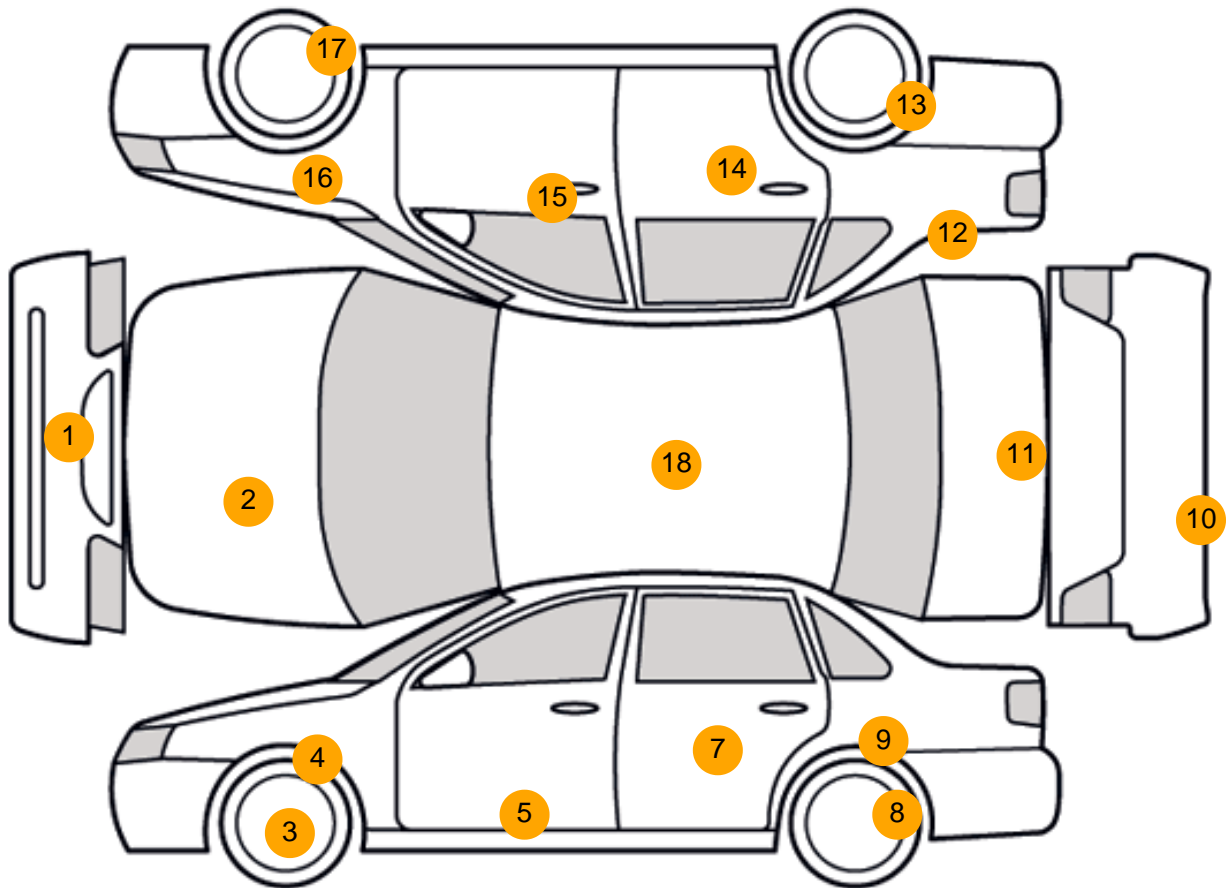
Condition Check

4: Wing nsf
Poor Previous Repair
Poor Paint

7: Door nsr
Dented
With Paint Damage

9: Qtr Panel nsr
Dented
With Paint Damage

11: Boot Lid
Dented
With Paint Damage

12: Qtr Panel osr
Poor Previous Repair
Poor Paint

15: Door osf
Dented
With Paint Damage
