VEHICLE INSPECTION REPORT

GU62CFY

Toyota Auris 1.33 Dual VVTi Colour Collection 5dr

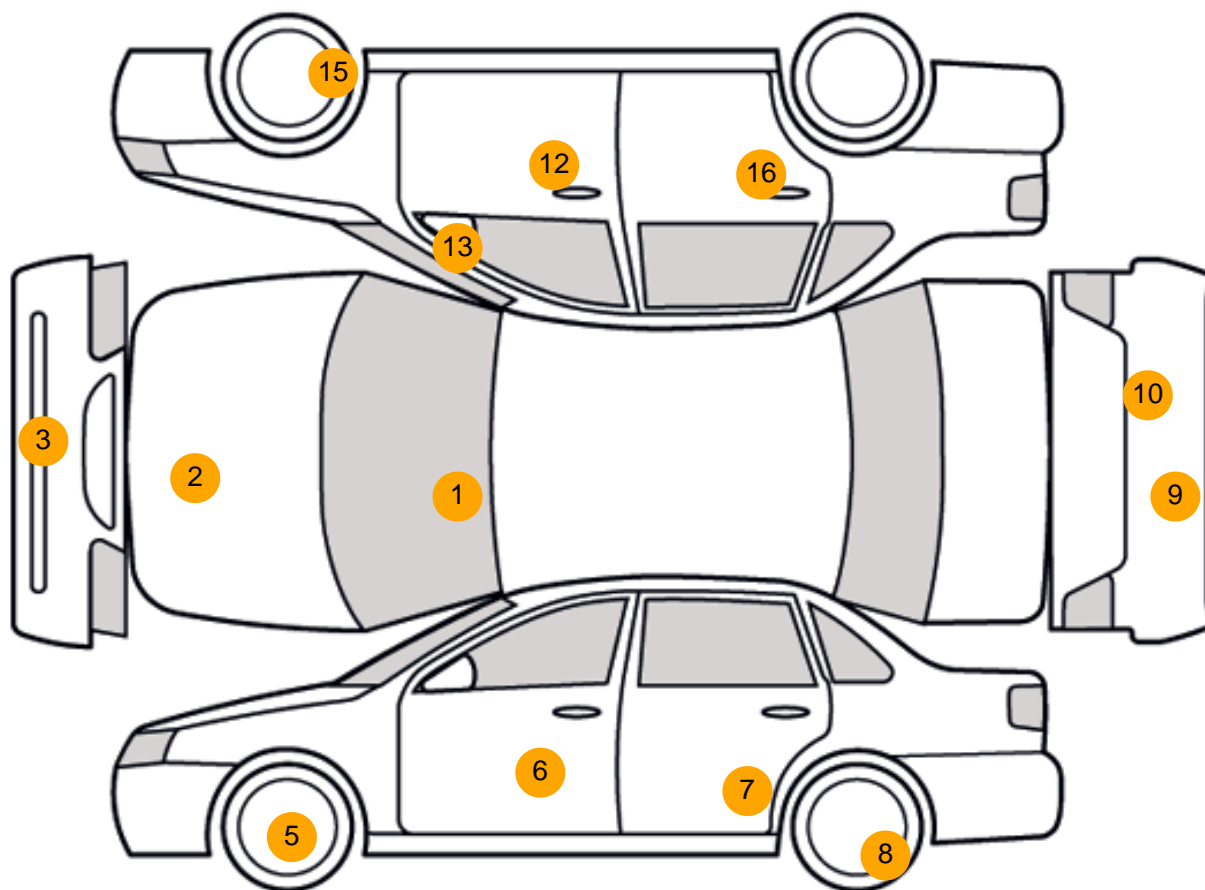
Condition Check

12: Door osf
Poor Previous Repair
Paint Flake

13: Door Mirror Assy osf
Broken
Replace

15: Wheel osr
Damaged
Replace
