# VEHICLE INSPECTION REPORT

**KY12KXL**

## Seat Alhambra 2.0 TDI CR Ecomotive SE 5dr

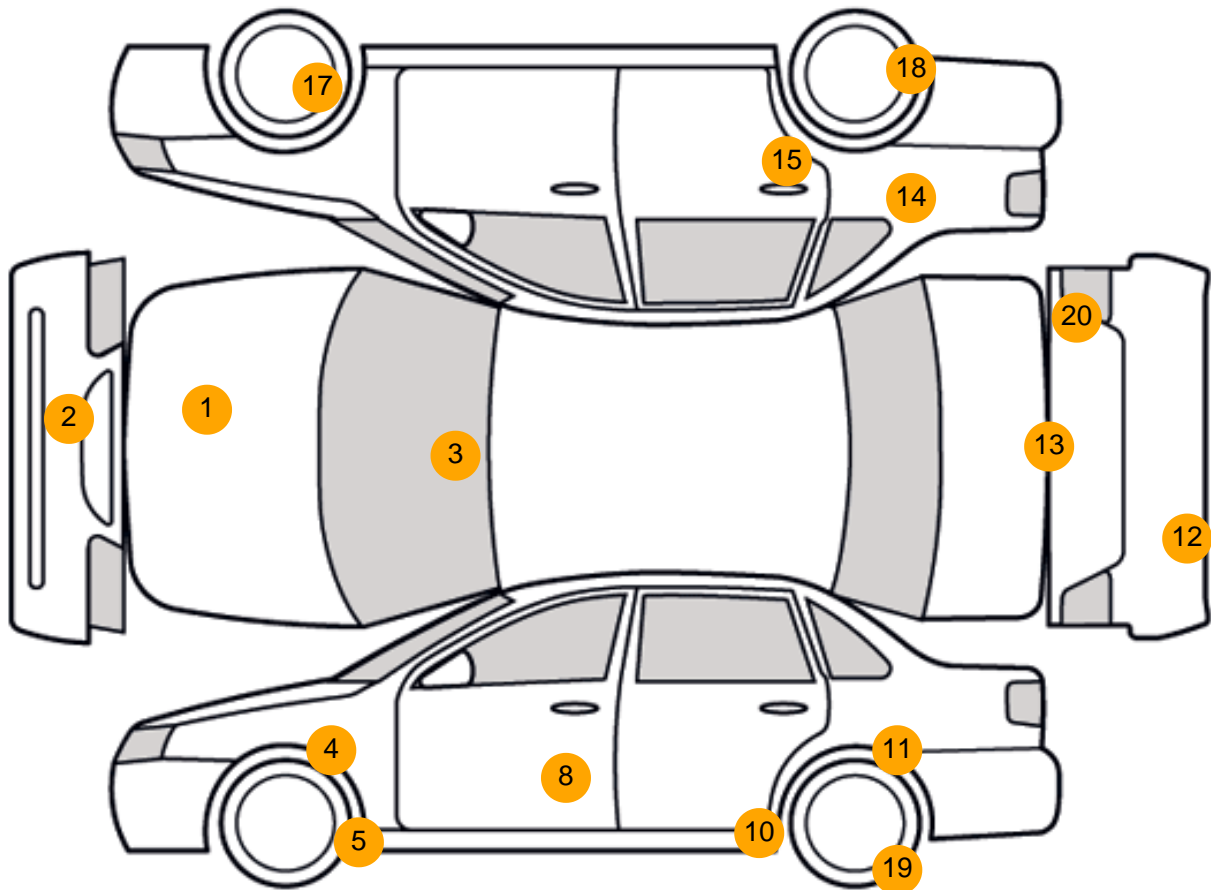
## Condition Check

£65 ADDITIONAL FEE Last service 21/01/2025 @ 113463 miles (12 SERVICES (4 MAIN DEALER)) Osr wheel arch trim insecure
