# VEHICLE INSPECTION REPORT

**GU63BZG**

## BMW 1 Series 116i Sport 5dr

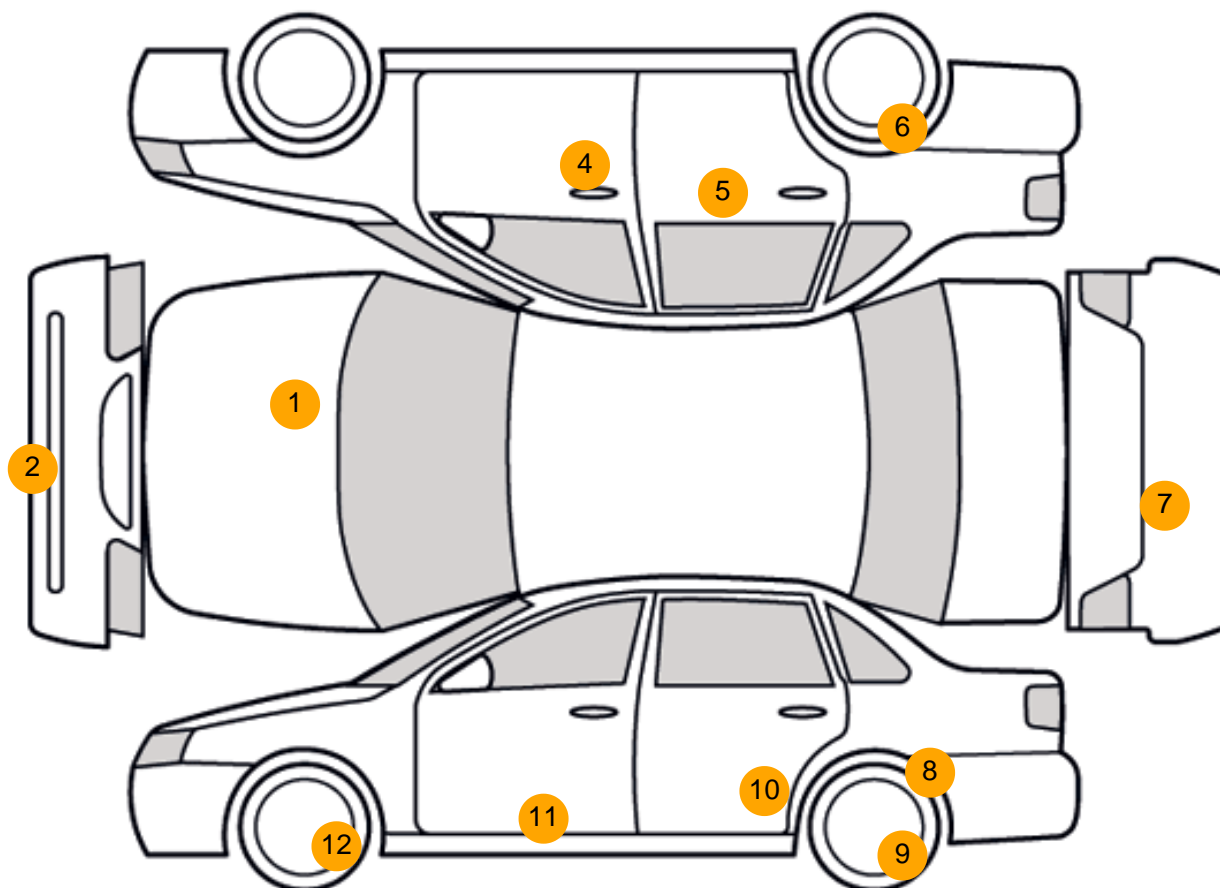
## Condition Check

£100 ADDITIONAL FEE Last service 10/07/2024 @ 61746 miles (8 SERVICES (2 MAIN DEALER)) Bonnet and front bumper out of line
