# VEHICLE INSPECTION REPORT

**HV66YKS**

## Kia Sportage 1.6 GDi 1 5dr

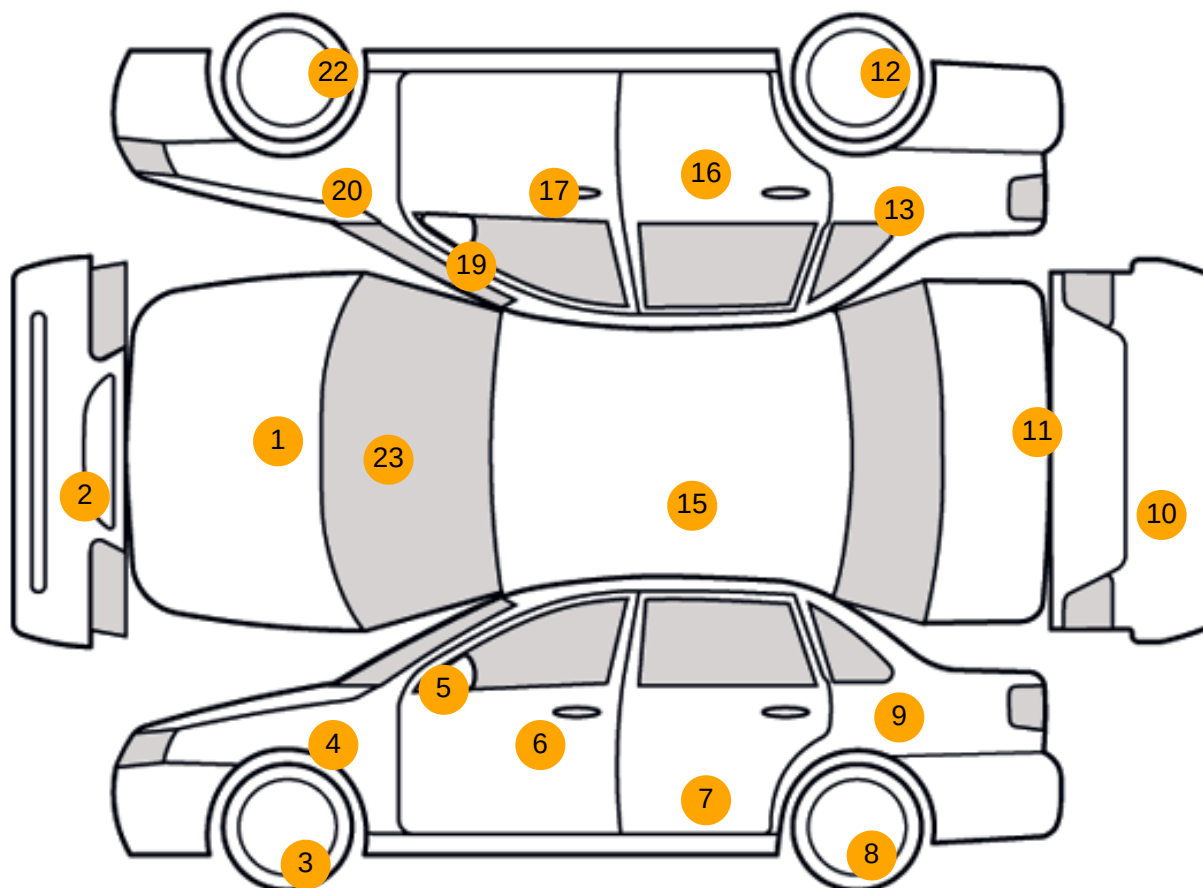
## Condition Check

4: Wing nsf  
Dented  
With Paint Damage

6: Door nsf  
Dented  
With Paint Damage

7: Door nsr  
Dented  
With Paint Damage

9: Qtr Panel nsr  
Poor Previous Repair  
Poor Paint

16: Door osr  
Poor Previous Repair  
Poor Paint
