# VEHICLE INSPECTION REPORT

**RX15VDA**

## Kia Rio 1.4 CRDi 3 5dr

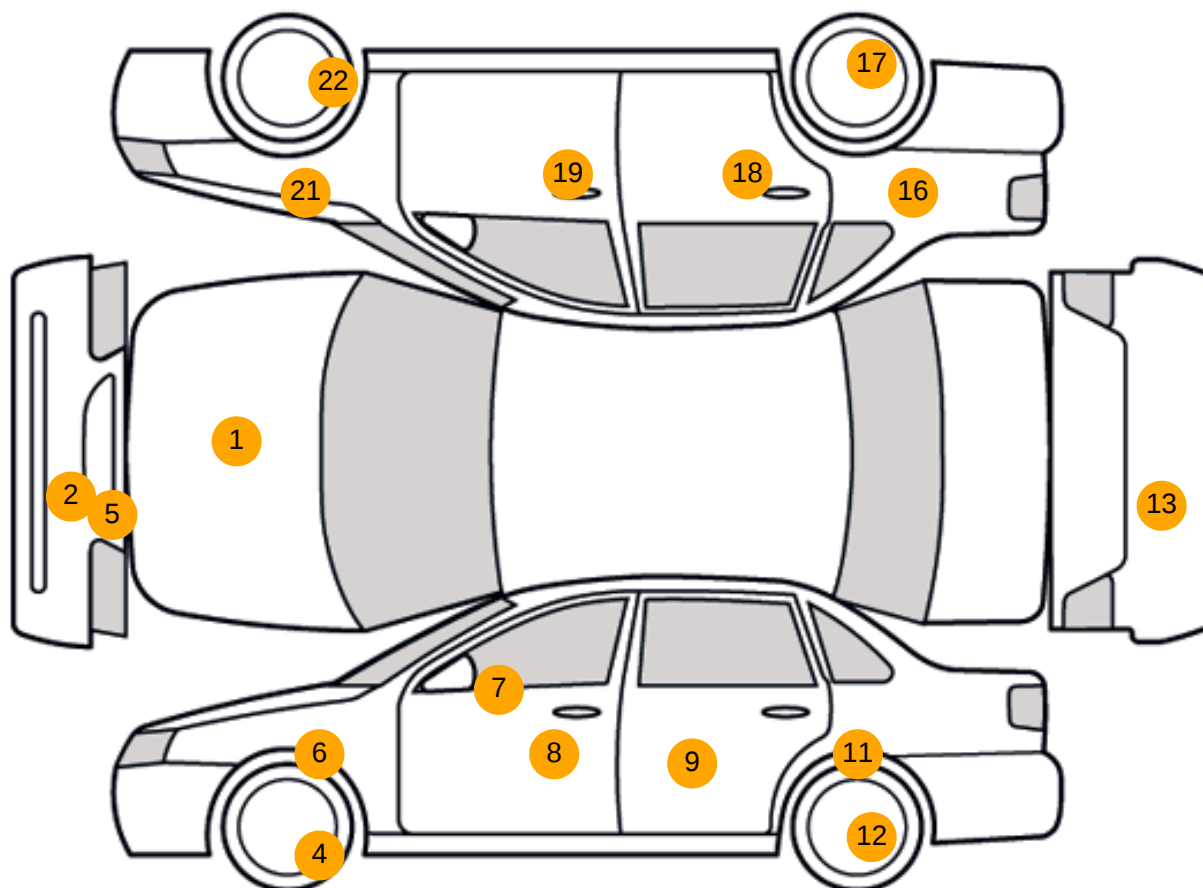
## Condition Check

6: Wing nsf  
Dented  
With Paint Damage

7: Door Mirror Assy nsf  
Broken  
Replace

11: Qtr Panel nsr  
Dented  
With Paint Damage

16: Qtr Panel osr  
Dented  
With Paint Damage
