VEHICLE INSPECTION REPORT

CN13KJF

Nissan Qashqai 1.6 dCi 360 5dr [Start Stop]

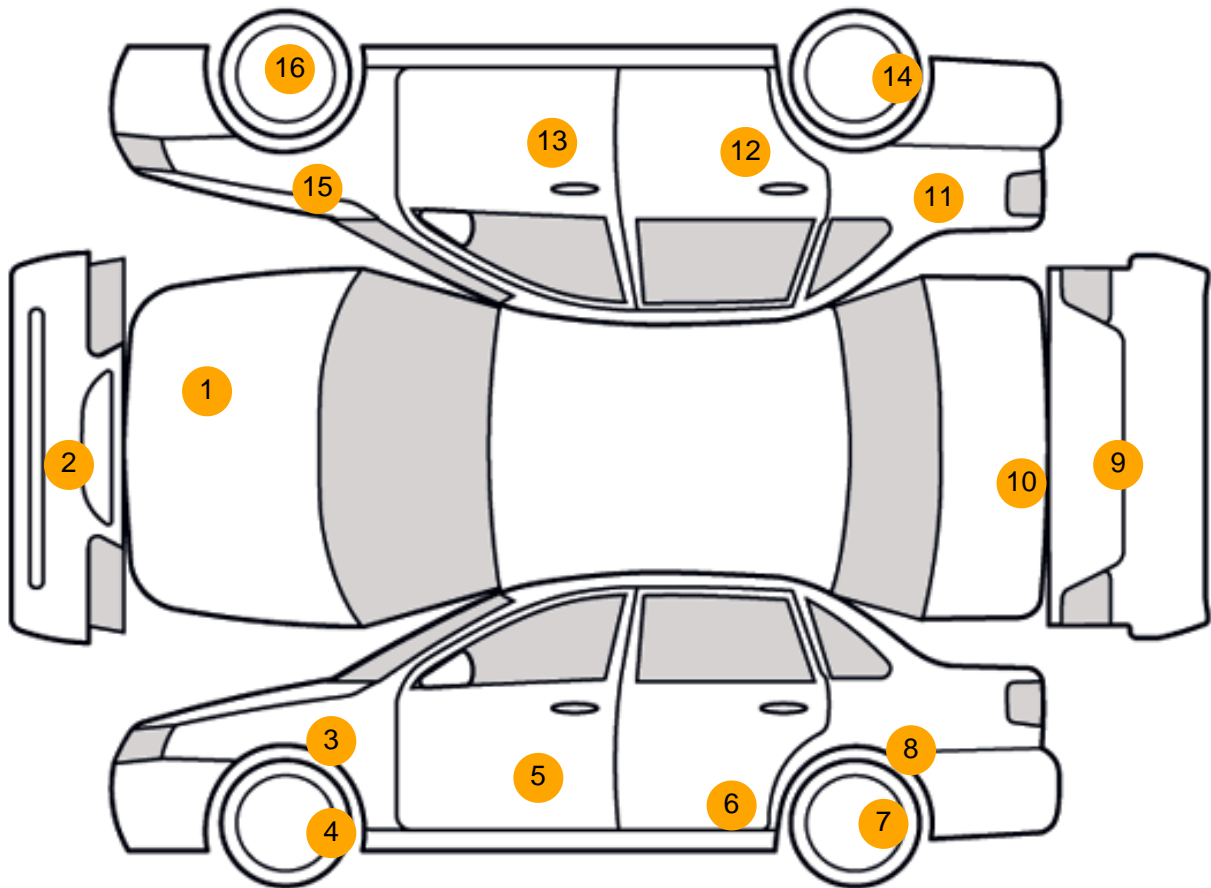
Condition Check

2: Bumper Front
Poor Previous Repair
Poor Paint

5: Door nsf
Poor Previous Repair
Poor Paint

6: Door nsr
Poor Previous Repair
Poor Paint

8: Qtr Panel nsr
Poor Previous Repair
Poor Paint

9: Bumper Rear
Poor Previous Repair
Poor Paint

13: Door osf
Poor Previous Repair
Poor Paint

15: Wing of
Dented
With Paint Damage
