VEHICLE INSPECTION REPORT

YK67WBZ

Toyota Yaris 1.5 Hybrid Icon 5dr CVT

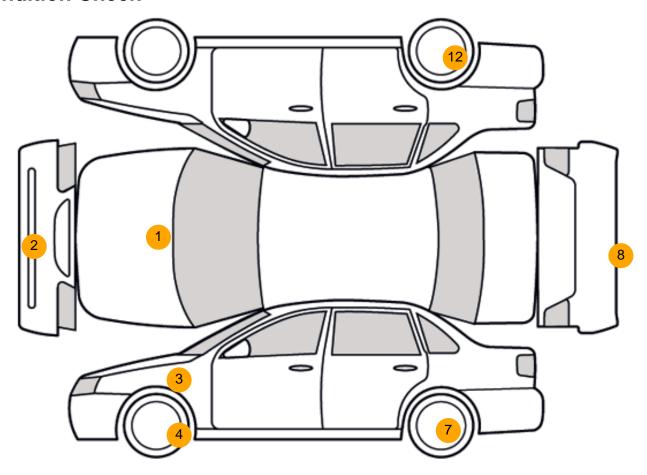
Condition Check

| Inspection | | Vehicle | | | nama |
|---|---|---|---|---|---|
| Serious Damage? | No | VAT | Margin | | 2 GRADE |
