# VEHICLE INSPECTION REPORT

LG67LXY

## Audi A3 1.5 TFSI S Line 5dr

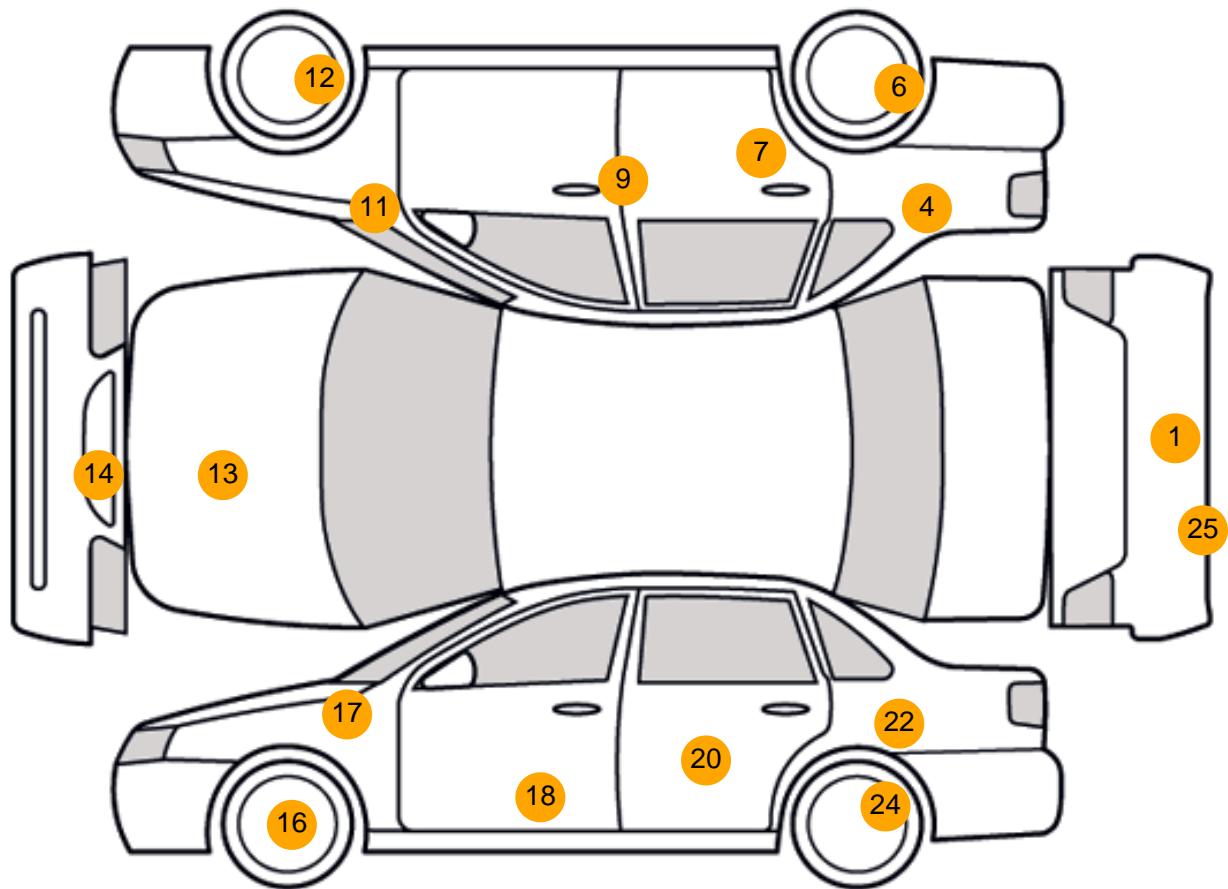
## Condition Check

1: Bumper Rear  
Scratched  
25 to 100mm Thru Paint

2: Bumper Rear  
Scratched  
Over 25mm Not Thru Paint
