VEHICLE INSPECTION REPORT

GU23JFK

Toyota C-Hr 1.8 Hybrid GR Sport 5dr CVT

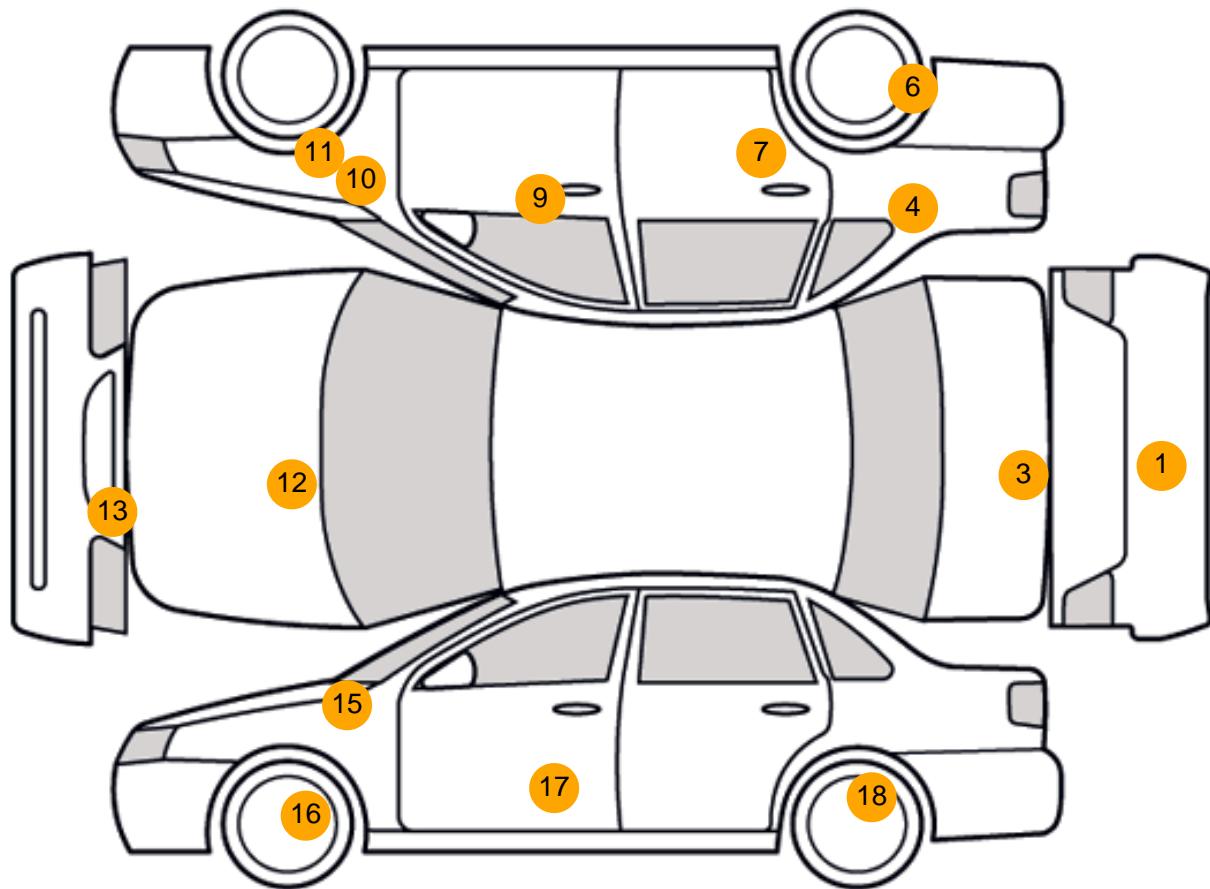
Condition Check

1: Bumper Rear
Chipped
Multiple Chips

2: Bumper Rear
Scratched
Over 25mm Not Thru Paint

3: Boot Lid
Dented
Over 2 UpTo 10mm
