VEHICLE INSPECTION REPORT

GX15RRU

Ford B-Max 1.6 Zetec 5dr Powershift

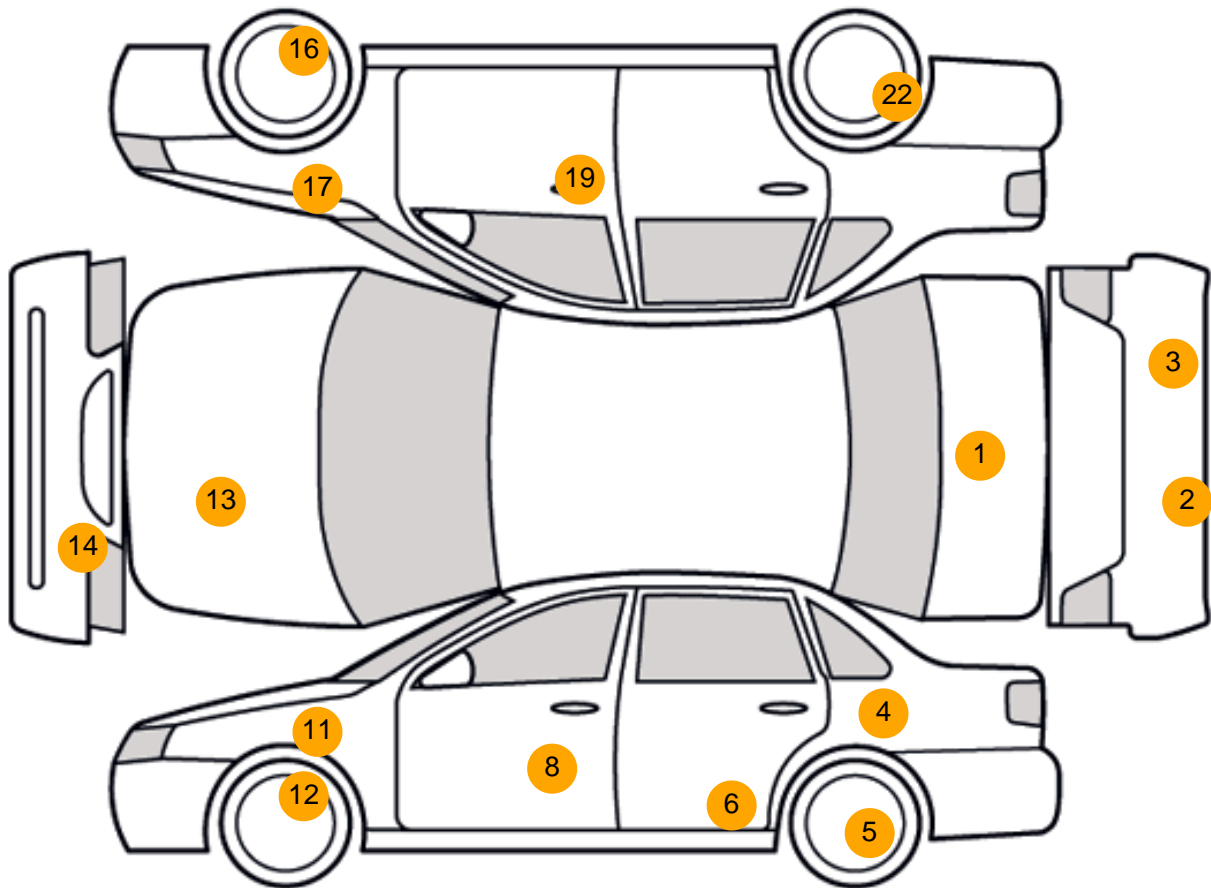
Condition Check

£100 ADDITIONAL FEE. Last Service: 07/10/2021 at 26935 miles. (5 services (3 main dealer)). Book & print.
Rear bumper misaligned vibration at idle
