Vehicle Inspection Report

Reg: EY18LYT

Make VAUXHALL Model INSIGNIA ELITE NAV TURBO - 1490cc Mileage 39,858 miles		Body Type Fuel Type Transmission Gears	Hatchbae Petrol Manual 6	Doors Colour Year of MFR Date First Reg	5 V5 Loc. Blue No. Ke 2018 31/05/2018			
Tyres & W	Vheels				Interior Condi	ition	Service	History
OSF Dep NSF Dep OSR Dep NSR Dep	oth (	5 mm 6 mm 6 mm 6 mm	Alloys Alloys That Need Refurb Tools Spare	Yes 4 Yes Space Saver	Carpets Upholstery Seats Parcel Shelf Odour	Averaç Averaç Averaç f Yes No	ge Histo	-
Extras								
Metallic I Air Condi Stereo Keyless I Phone Ki	ditioning Entry	Yes Radio No	Sun Roof Sat Nav Towbar	Yes No Built In No Yes	terior ec Windows uise umber of Seats eversing Camera	Leather 4 Yes 5 Yes	Electric Seats Heated Seats Xenons Parking Sensors EML	No Yes No Front & Rear No

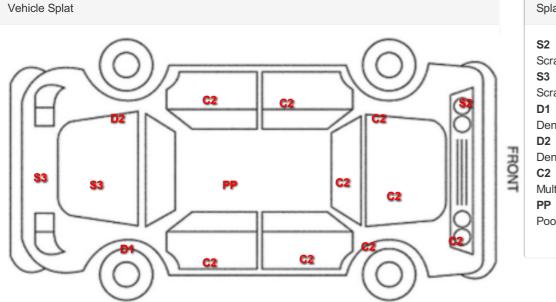
Damage Lines

Component Condition **Bumper Rear** Scratched Boot Lid Scratched Qtr Panel nsr Dented Door nsr Chipped Door nsf Chipped Wing nsf Scratched Wing nsf Chipped Screen Front Chipped Bonnet Scratched Bonnet Chipped **Bumper Front** Scratched **Bumper Front** Chipped Wing osf Scratched Wing osf Chipped Door osf Scratched Door osf Chipped Door osr Scratched Door osr Chipped Qtr Panel osr Scratched Qtr Panel osr Dented Poor Previous Repair

Severity Over 100mm Thru Paint Over 25mm Thru Paint With Paint Damage **Multiple Chips Multiple Chips** Over 25mm Not Thru Paint 1 To 5 Over 10mm Over 25mm Not Thru Paint 1 To 5 25 to 100mm Thru Paint **Multiple Chips** Over 25mm Not Thru Paint 1 To 5 Over 25mm Not Thru Paint 1 To 5 Over 25mm Not Thru Paint 1 To 5 Over 25mm Not Thru Paint 2 Or Less UpTo 10mm Paint Flake

Repair Refinish Refinish Repair and Refinish Refinish Refinish Machine Polish Smart Repair Replace Machine Polish Smart Repair Smart Repair Smart Repair Machine Polish Smart Repair Machine Polish Smart Repair Machine Polish Smart Repair Machine Polish Smart Repair Refinish
